Debris/Ice/TPS Assessment and Integrated Photographic Analysis Of Shuttle Mission STS-100

**DEBRIS/ICE/TPS ASSESSMENT
AND
INTEGRATED PHOTOGRAPHIC ANALYSIS
OF
SHUTTLE MISSION STS-100**

April 19, 2001

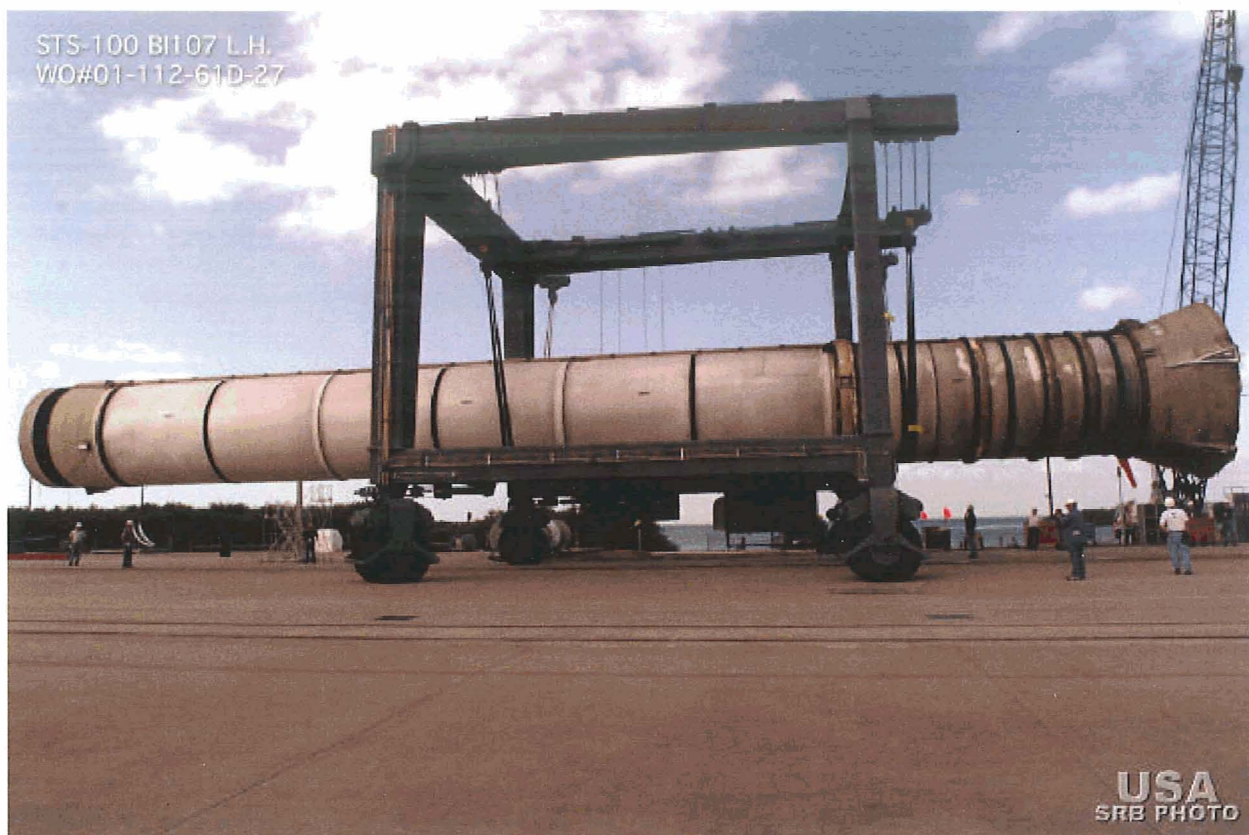
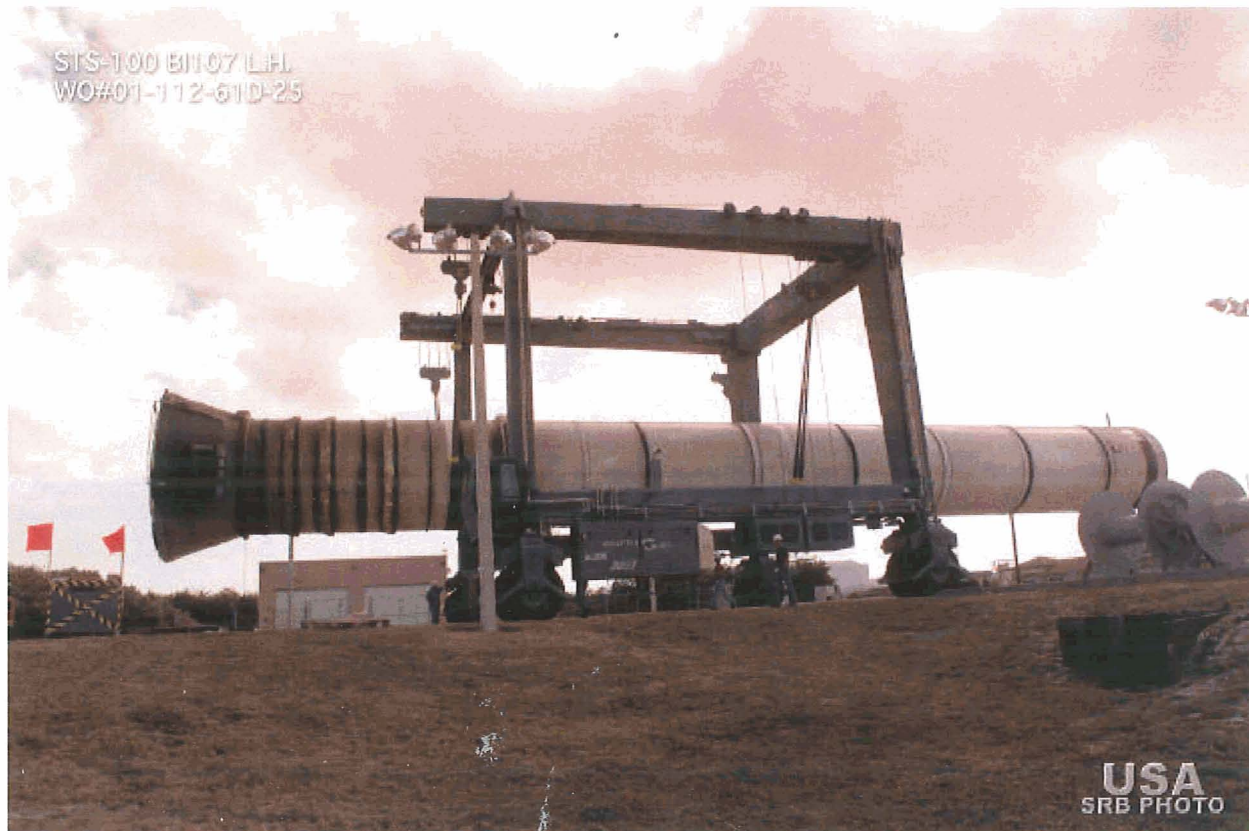
Photo 11: SRB Post Flight Condition

Both SRB's were found in good condition regarding debris assessment

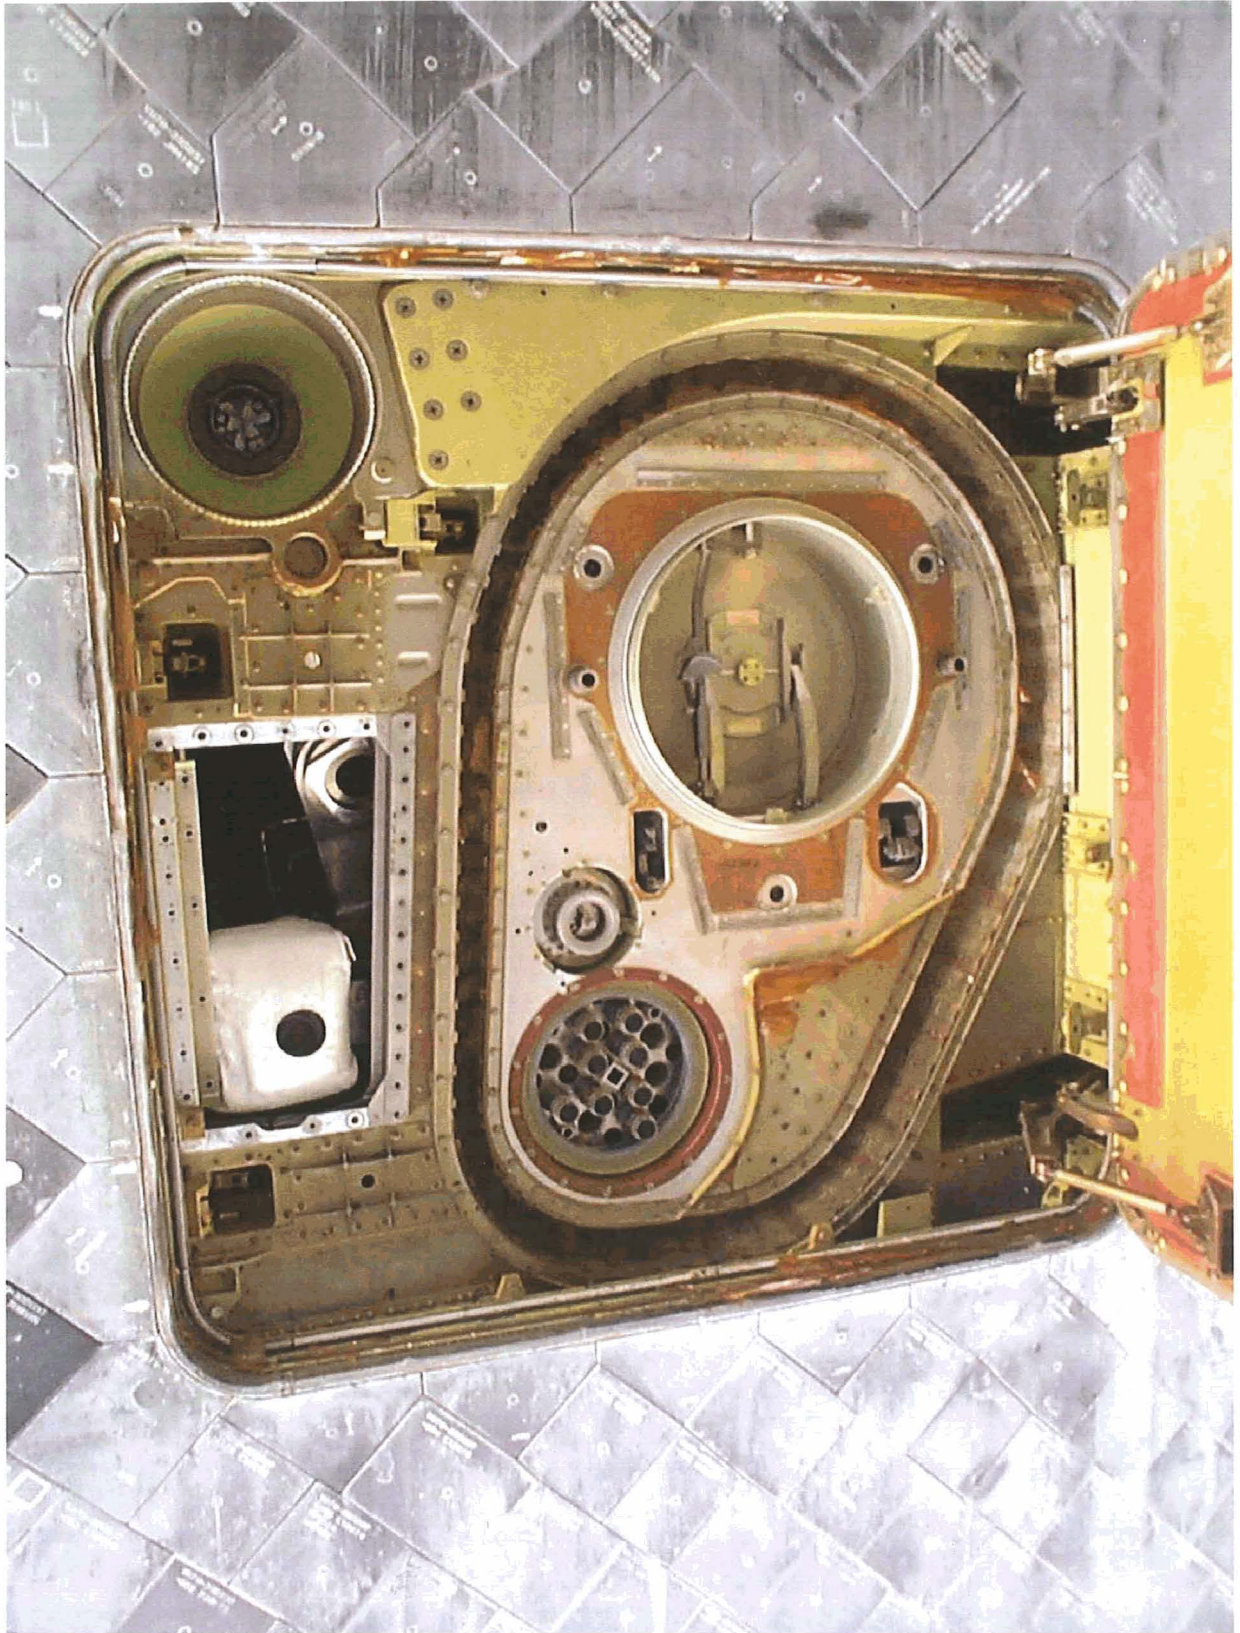
Photo 14: LO2 ET/ORB Umbilical

There were no TPS anomalies on the LO2 ET/ORB umbilical. Ice and frost in the LH2 recirculation line bellows and on both burst disks was typical. Likewise, a typical amount of ice/frost had accumulated on the LH2 ET/ORB umbilical purge barrier outboard side, forward, and aft surfaces. Typical ice/frost fingers were present on the pyro canister and plate gap purge vents. No unusual vapors or cryogenic drips had appeared during tanking, stable replenish, and launch.

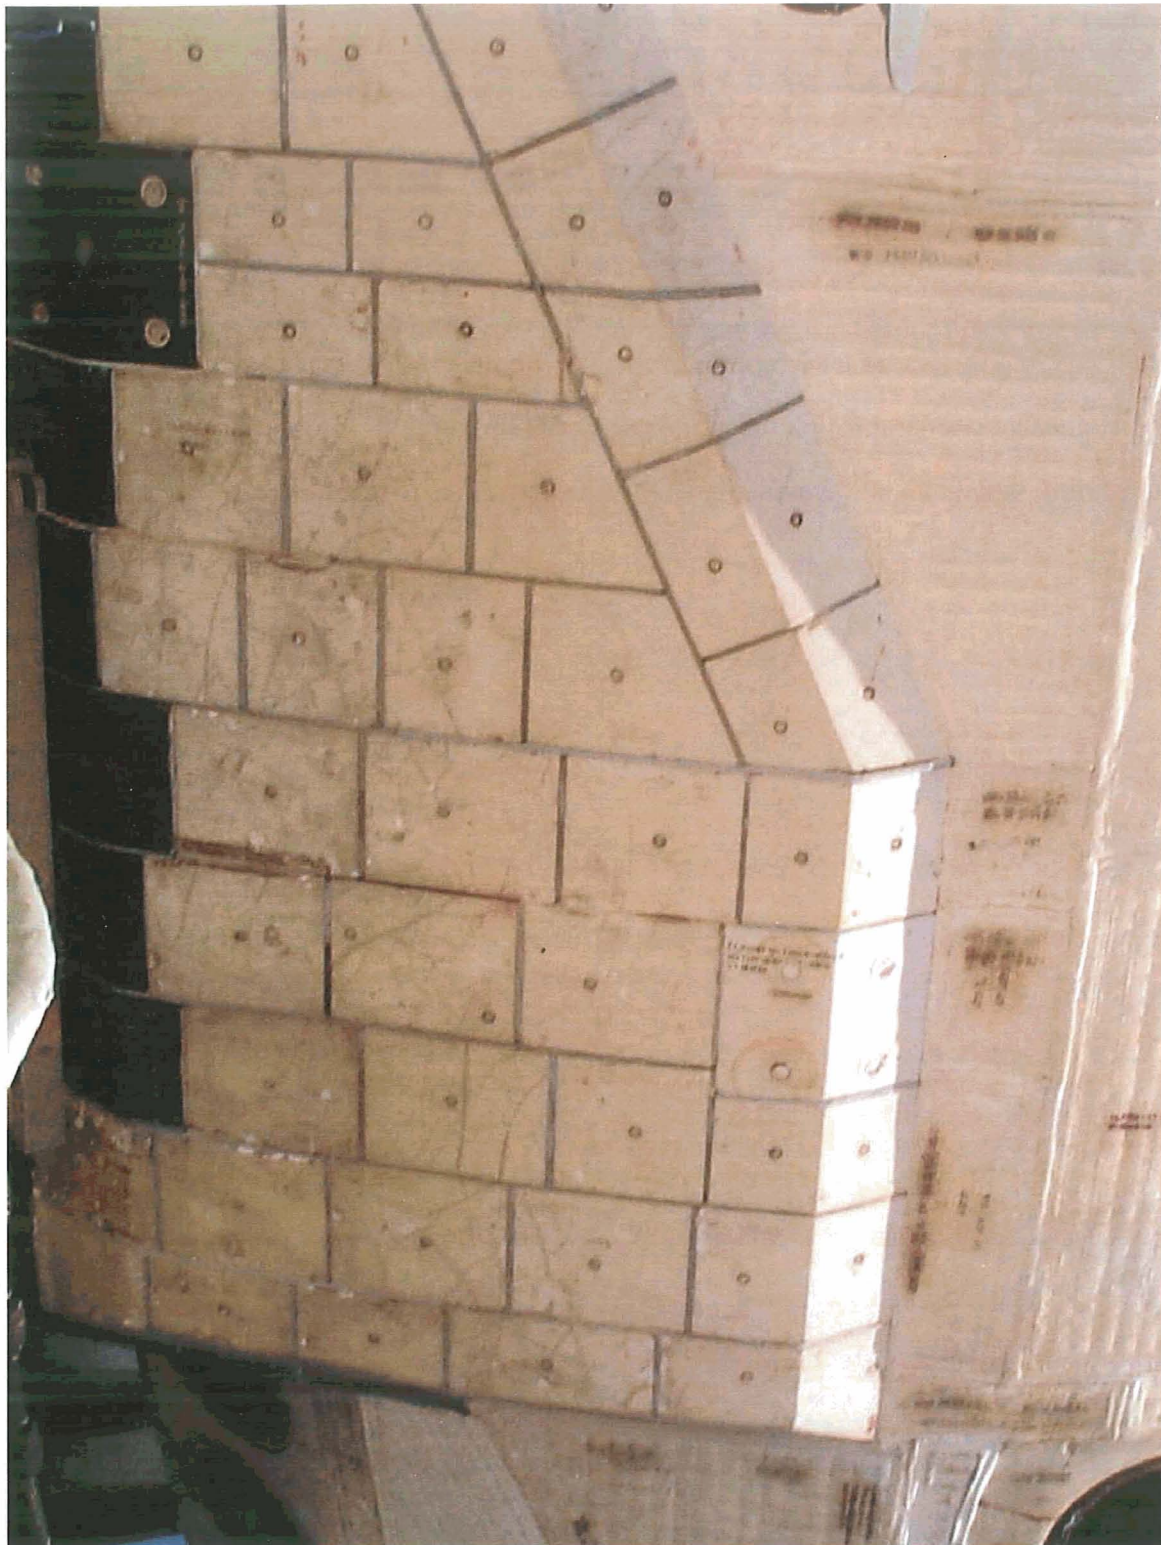
Photo 16: LH OMS Pod TPS

The OMS pods tiles had a typical amount of damage. No unusual tile damage or evidence of tile movement, as seen in lift-off films, was observed on the OMS pods.

Due to the motion observed during the film review on the LH OMS Pod Based post-landing inspections were performed on the OMS Pod structure and TPS. Inspections revealed no damage to the TPS or underlying structure of the OMS Pod.

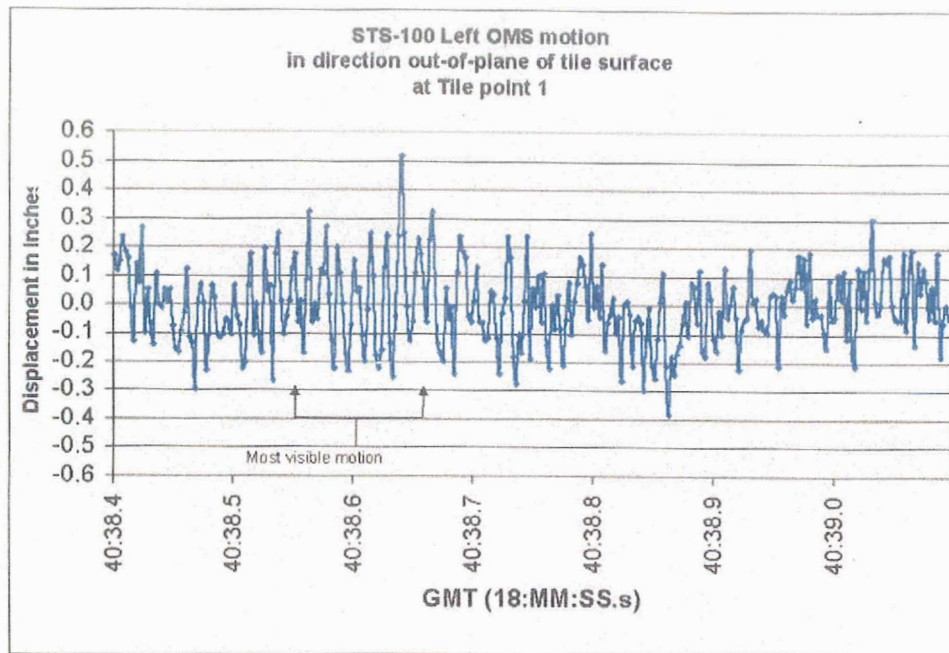
Figure 2.1(B) Tile Displacement in Inches

The motions of both mid-panel points in the out-of-plane direction showed maximum deflections of 0.7 inches for any single movement (implying a zero-to-peak amplitude of 0.35 inches) occurring just after 18:40:38.6 UTC. See Figure 2.1(B).

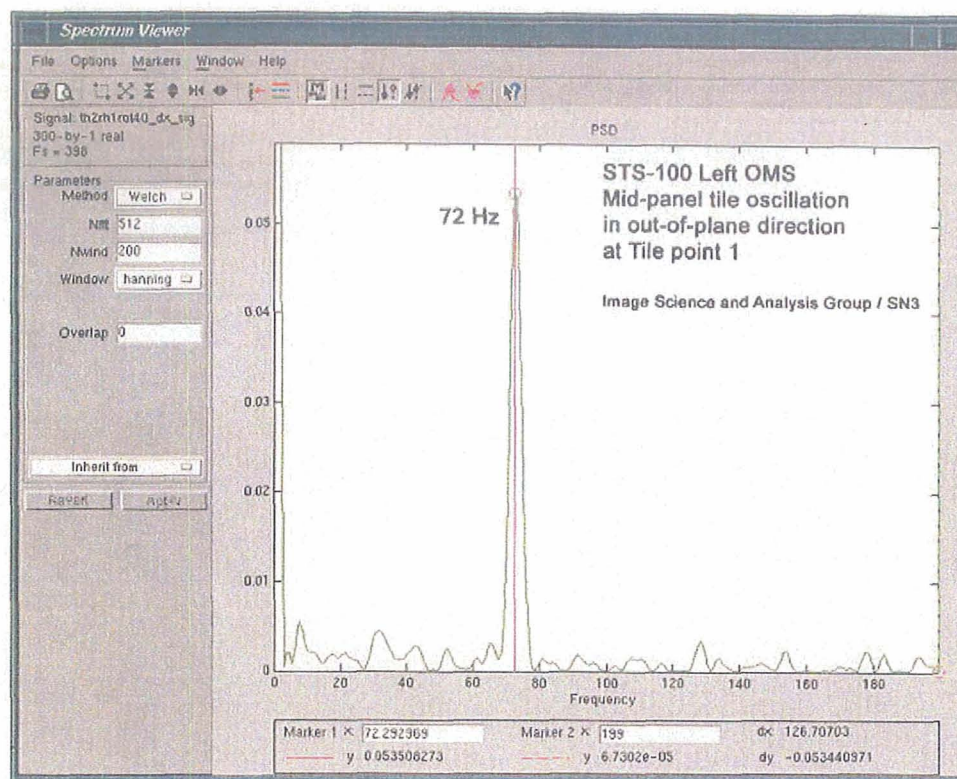
Figure 2.1(C) Frequency Plot of Tile Motion

Power spectral density plots for these motions show strong 72-73 hertz oscillations. See Figure 2.1(C). Similar spectral plots for the motion component that is perpendicular to this direction in the image show no dominant frequency of oscillation. Tracking uncertainty was estimated to be ± 0.15 inches.

Previous mission films were screened for visual indications of OMS Pod vibrations similar to that seen on STS-100. However, no motions of the magnitude of that seen on the left STS-100 OMS pod were found. (The previous missions screened were STS-77, STS-80, STS-83, STS-89, STS-94, STS-97, and STS-98)

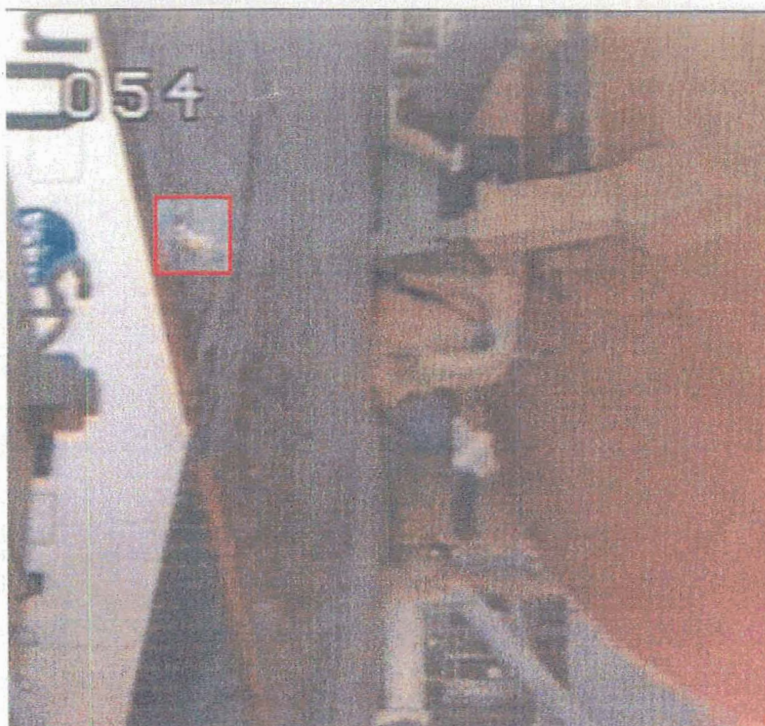
Figure 2.2.1 (A) Debris seen near Right Outboard Elevon. (Camera OTV054)

A single piece of debris first seen near the right outboard elevon moved in a $-Z$ direction between the ET aft dome and the RSRB during SSME ignition. This debris was not identified but it was possibly a piece of RCS paper (18:40:37.893 UTC). (Camera OTV054)

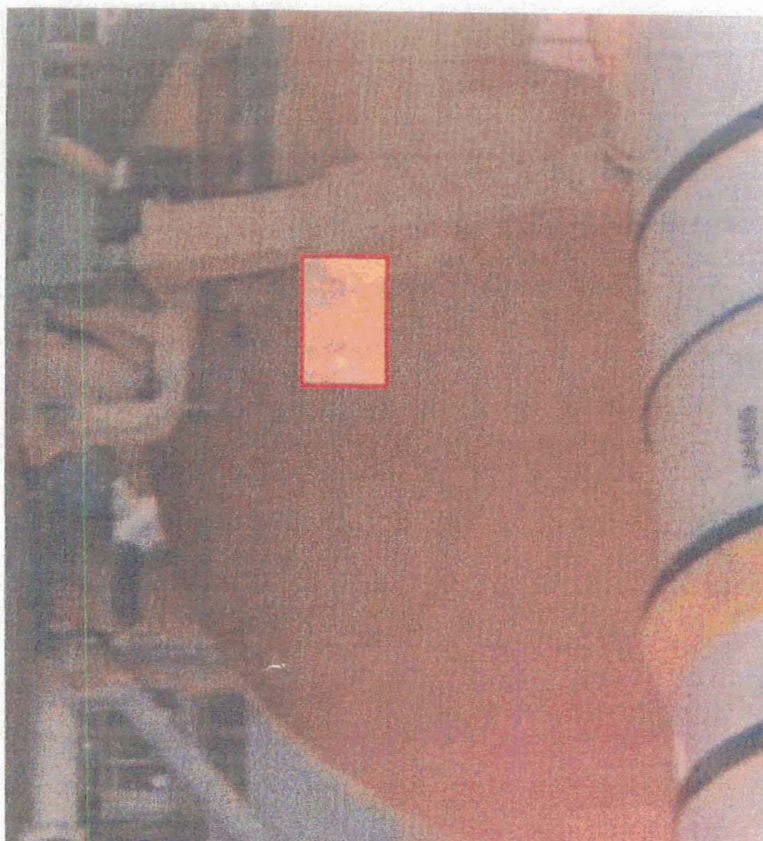
Figure 2.2.1 (B) Debris seen near +Y Vertical Strut. (Camera OTV054)

Several pieces of white-colored debris (probable frost) were seen falling aft from the aft surface of the ET +Y vertical strut during SSME ignition (18:40:38.994 UTC). See Figure 2.2.1 (B). (Camera OTV054)

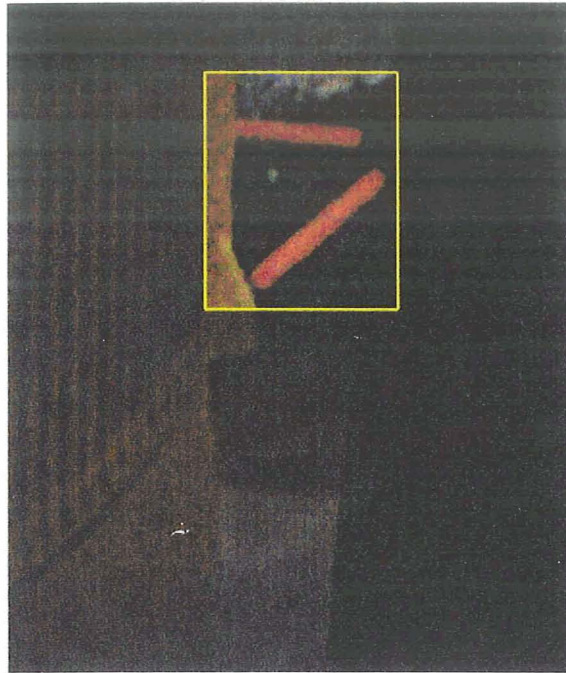
Figure 2.2.1 (D) Debris near ET/Orbiter Forward Attach Bipod. (Camera E34)

A single piece of light-colored debris was seen falling aft of the ET/Orbiter forward attach bipod during liftoff. This debris was probably ice from the forward ET LO2 feed line bellows (18:40:44.700 UTC). (Cameras OTV061, E34)

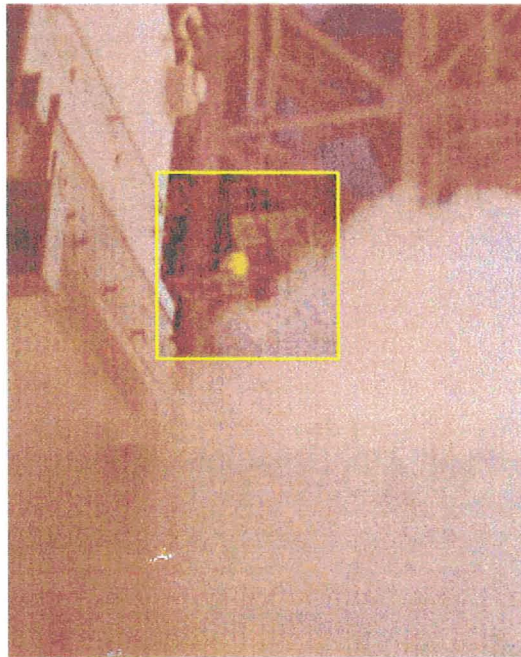
Figure 2.2.1 (E) Debris seen moving away from the SLV during Liftoff. (Camera E5)

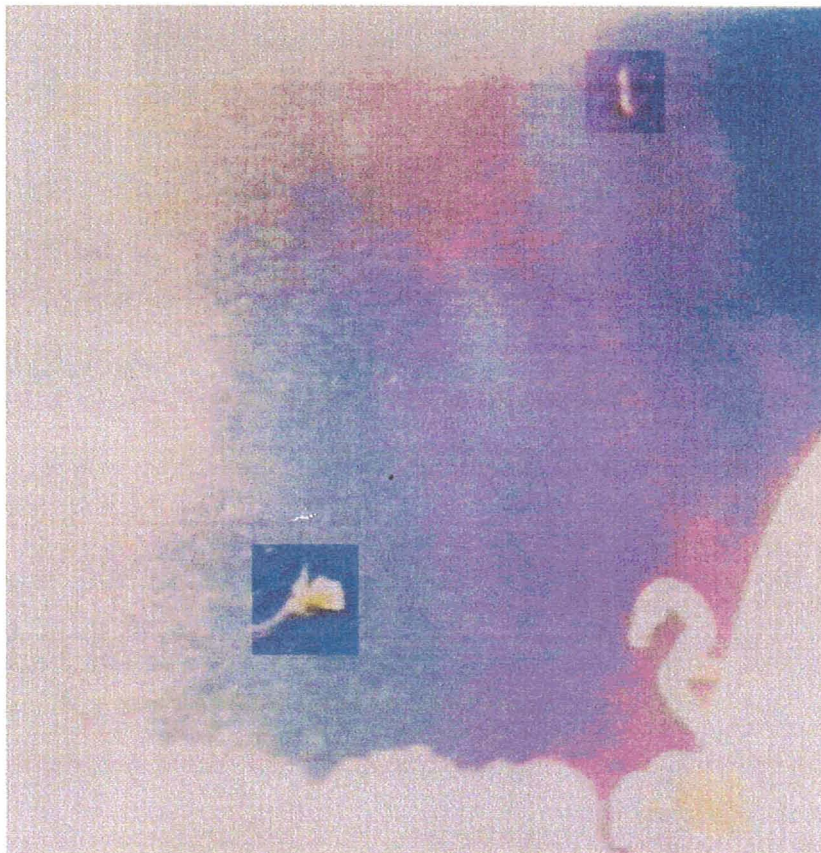
Figure 2.2.1 (F) Debris seen above LH2 TSM during Liftoff. (Camera OTV009)

Two pieces of light-colored, irregular-shaped unidentified debris were seen above the LH2 TSM during liftoff (18:40:44.7 UTC). (Camera OTV009)

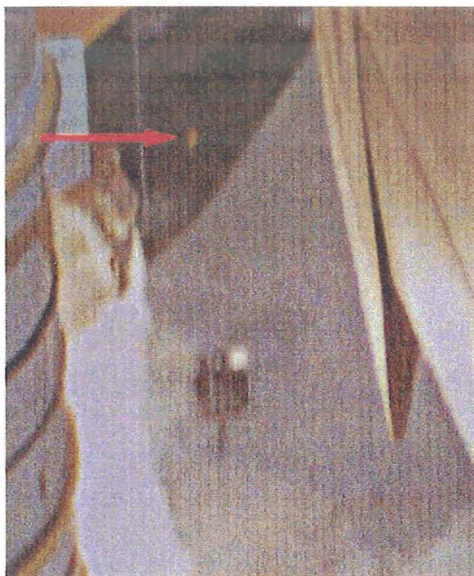
Figure 2.2.4 (A) Detached Umbilical Purge Barrier Material. (Camera E34)

A relatively large single-piece of light-orange-colored umbilical purge barrier material was seen detaching from the LH2 ET/Orbiter umbilical during liftoff (18:40:45.506 UTC). (Camera E34) Detached umbilical purge barrier material has been seen on previous mission imagery.

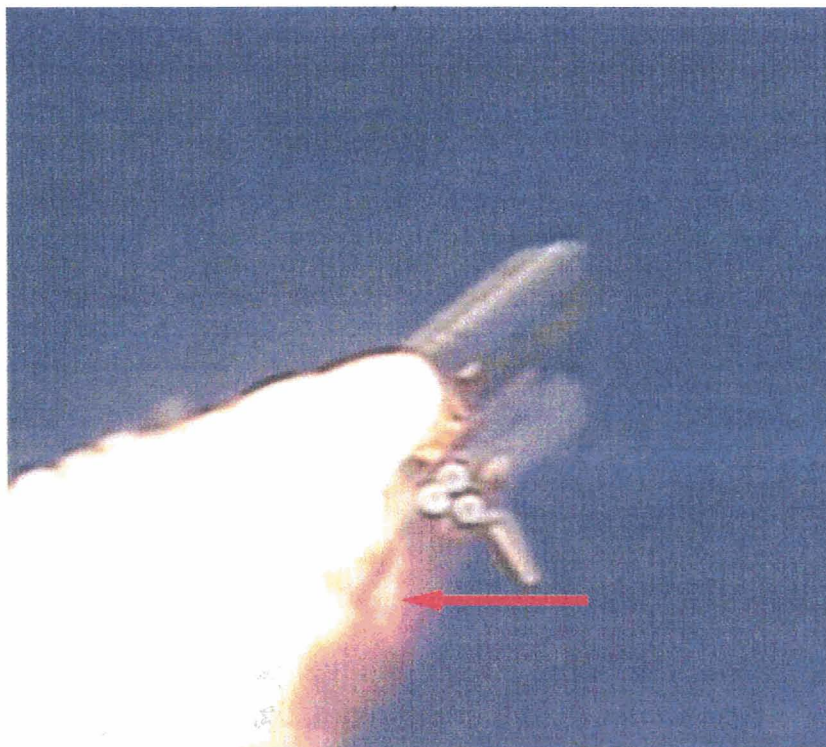
Figure 2.2.4 (B) Flare seen in SSME Exhaust Plume. (Camera KTV4A)

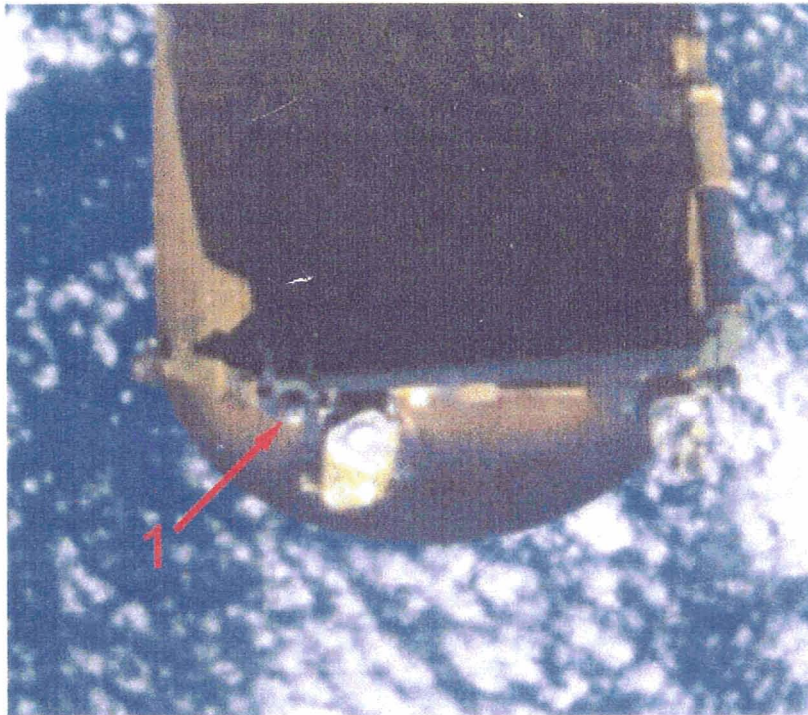
Figure 2.3.1. 16 mm Umbilical Well Camera View of Aft ET.

The LSRB separation appeared normal on the 16mm umbilical well camera films. Numerous light-colored pieces of debris (insulation), and dark debris (charred insulation) were seen throughout the SRB separation film sequence. Typical ablation and charring of the ET/Orbiter LH2 umbilical electric cable tray and the aft surface of the -Y upper strut fairing prior to SRB separation were seen. Pieces of TPS were seen to detach from the aft surface of the horizontal section of the -Y ET vertical strut. A long, flexible irregular-shaped, rope-like object was seen detaching from an unidentified location near the base of the LH2 umbilical prior to SRB separation (possibly a piece of umbilical purge barrier tape). Normal blistering of the fire barrier material on the outboard side of the LH2 umbilical was seen. Divoting of the TPS on the aft dome was also noted.

No anomalies were noted on the face of the LH2 umbilical after ET separation. The ET was in shadow for several seconds after separation, thus making detailed analysis of the ET at close

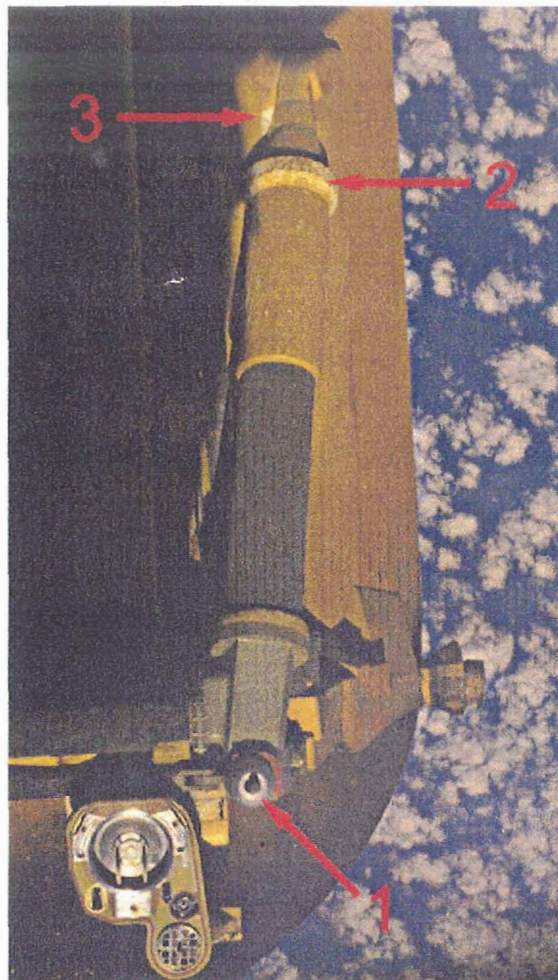
Figure 2.3.2 (A) 35mm Umbilical Well Camera View of Aft ET

The external tank appeared in excellent condition on the 35 mm umbilical well imagery of the STS-100 External Tank (ET-108). No anomalous conditions on the ET were noted. One special interest observation was noted:

Minor TPS chipping and very small divots (typical of previous missions) were seen on the aft LO2 feedline flanges and on the aft bracket over the press lines. Small, shallow areas of TPS erosion and divoting were visible on the forward flange of the +Y ET/Orbiter thrust strut. See Figure 2.3.2 (A), annotation 2). Typical ablation and divoting of the TPS on the vertical section of the +Y electric cable tray adjacent to the LO2 umbilical were detected. Small "popcorn" divots were seen on the ET aft dome as well as along the LO2 feedline just forward of the Orbiter aft attach strut. A slightly larger area of TPS ablation was seen on the LH2 tank TPS near the forward end of the +Y thrust strut. See Figure 2.3.2 (A), annotation 3. The face of the LO2 umbilical carrier plate appeared to be in excellent condition (no indication of damaged or missing lightning contact strips was detected). The red-colored purge seal on the EO-3 ball joint fitting was in place during ET separation. On previous missions, detached or missing seals from the EO-3 ball joint fitting have been noted.

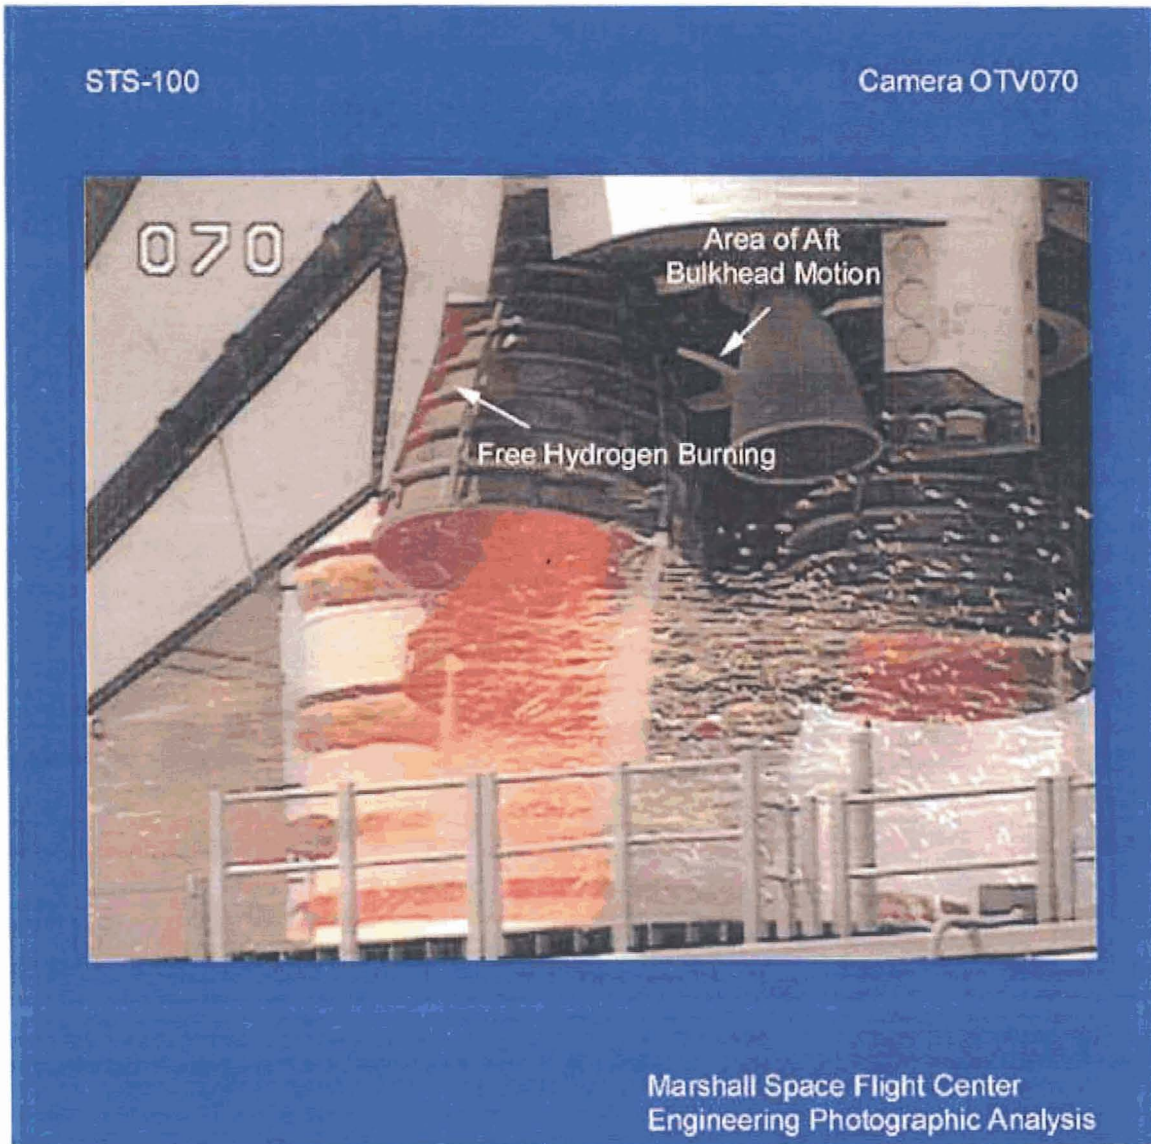
Free Hydrogen burning was observed near the vertical stabilizer at SSME ignition. This particular phenomenon is a typical occurrence during SSME ignition and appears to be within normal limits.

Figure 1. Free Hydrogen Burning

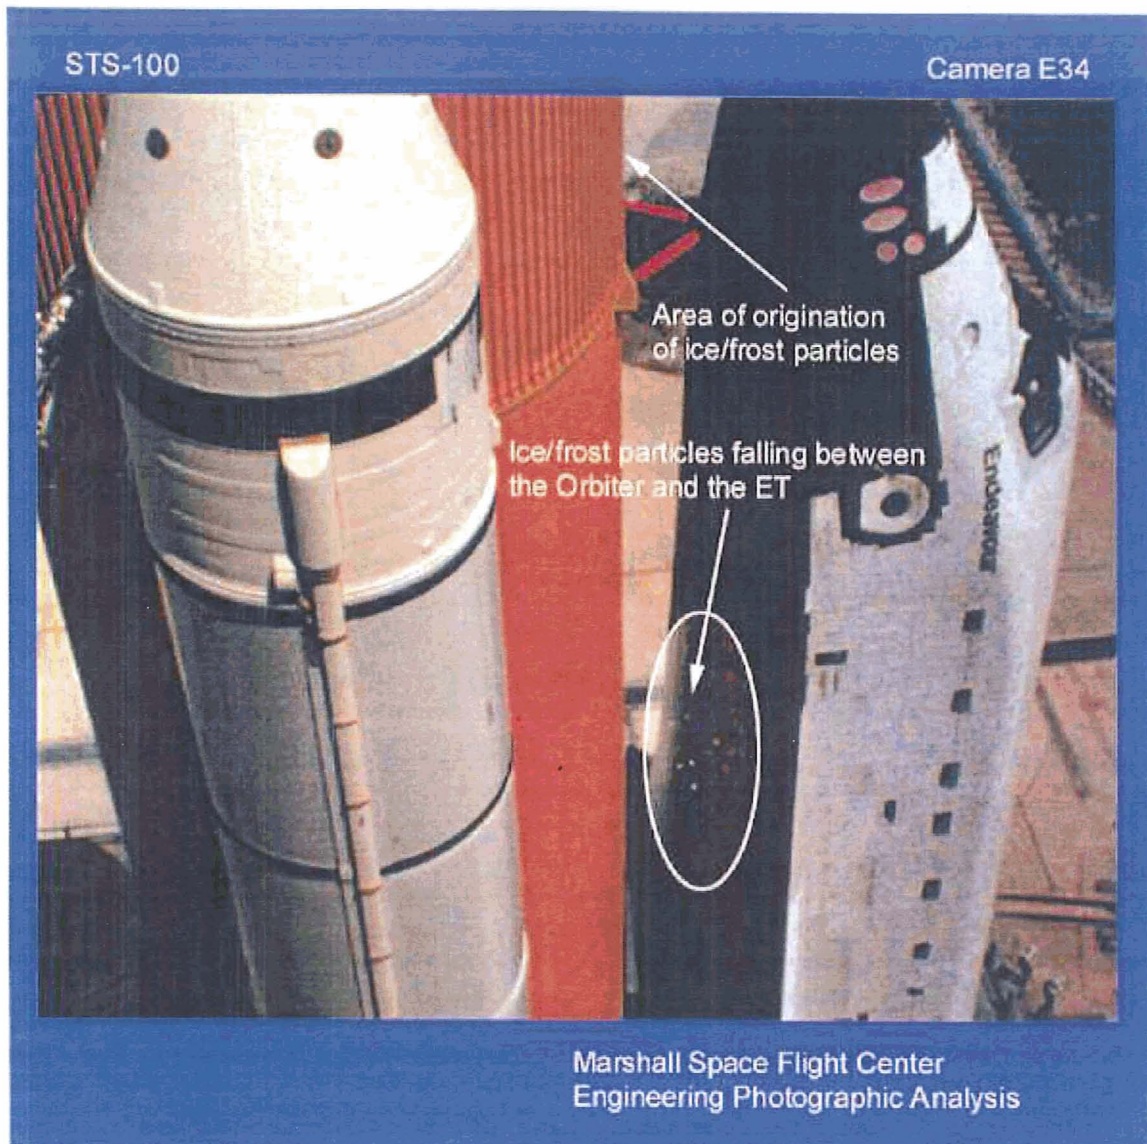
A number of ice/frost debris objects, apparently from the LOX Feedline on the ET, fall between the Orbiter and the ET. No impacts were observable and no damage was noted.

Figure 4. Ice/Frost Falls between the Orbiter and ET

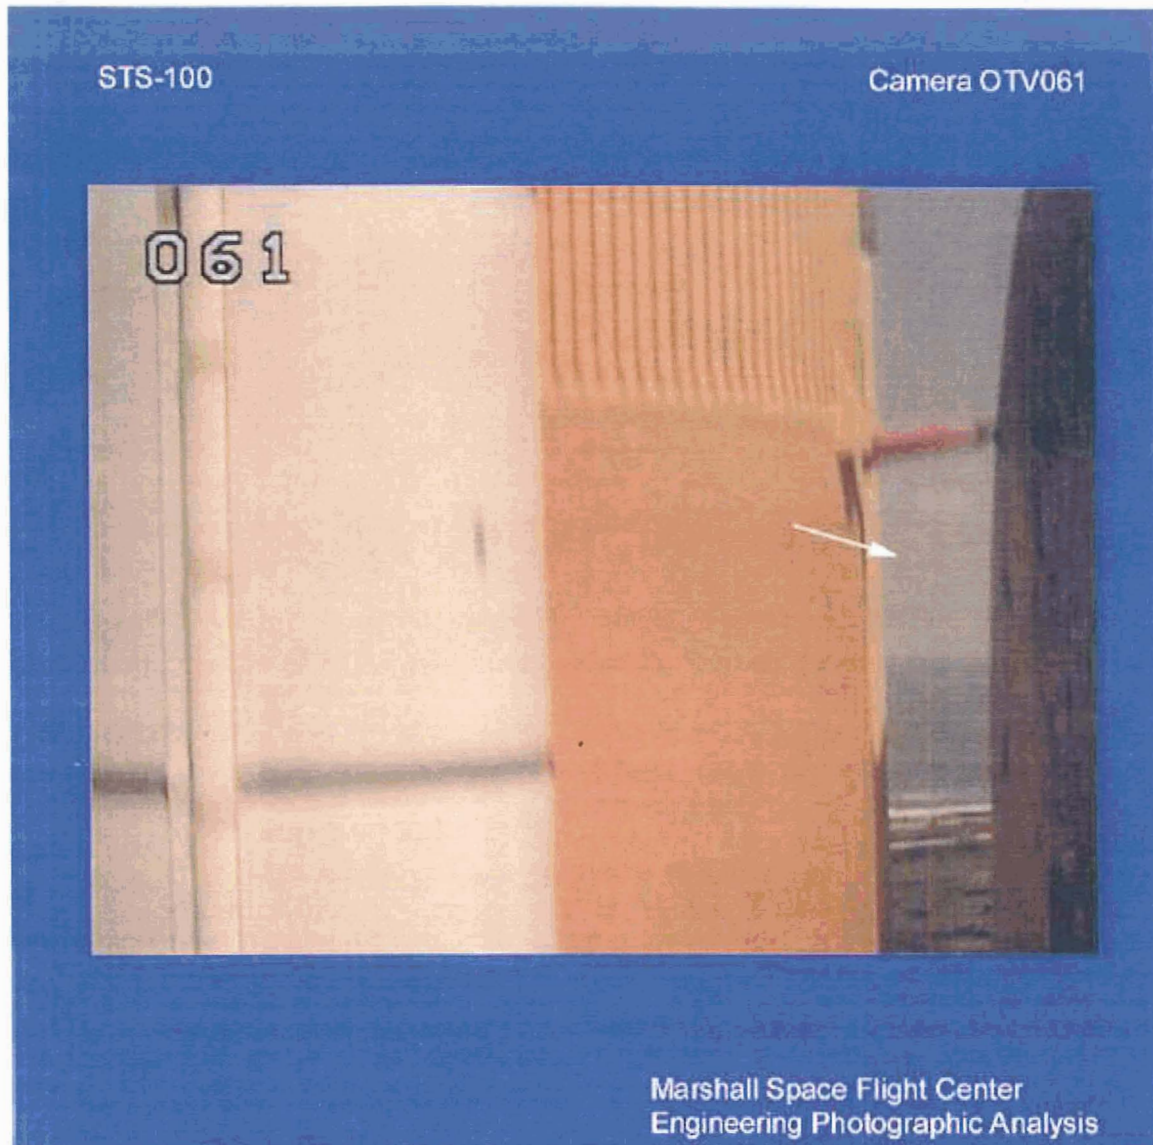
A small piece of ice or frost, apparently originating from the LOX Feedline forward of the ET-Orbiter attach bipod, was noted falling between the Orbiter and the ET. No impact with the ET or Orbiter could be discerned.

Figure 5. Ice/Frost Falls Between Orbiter and ET

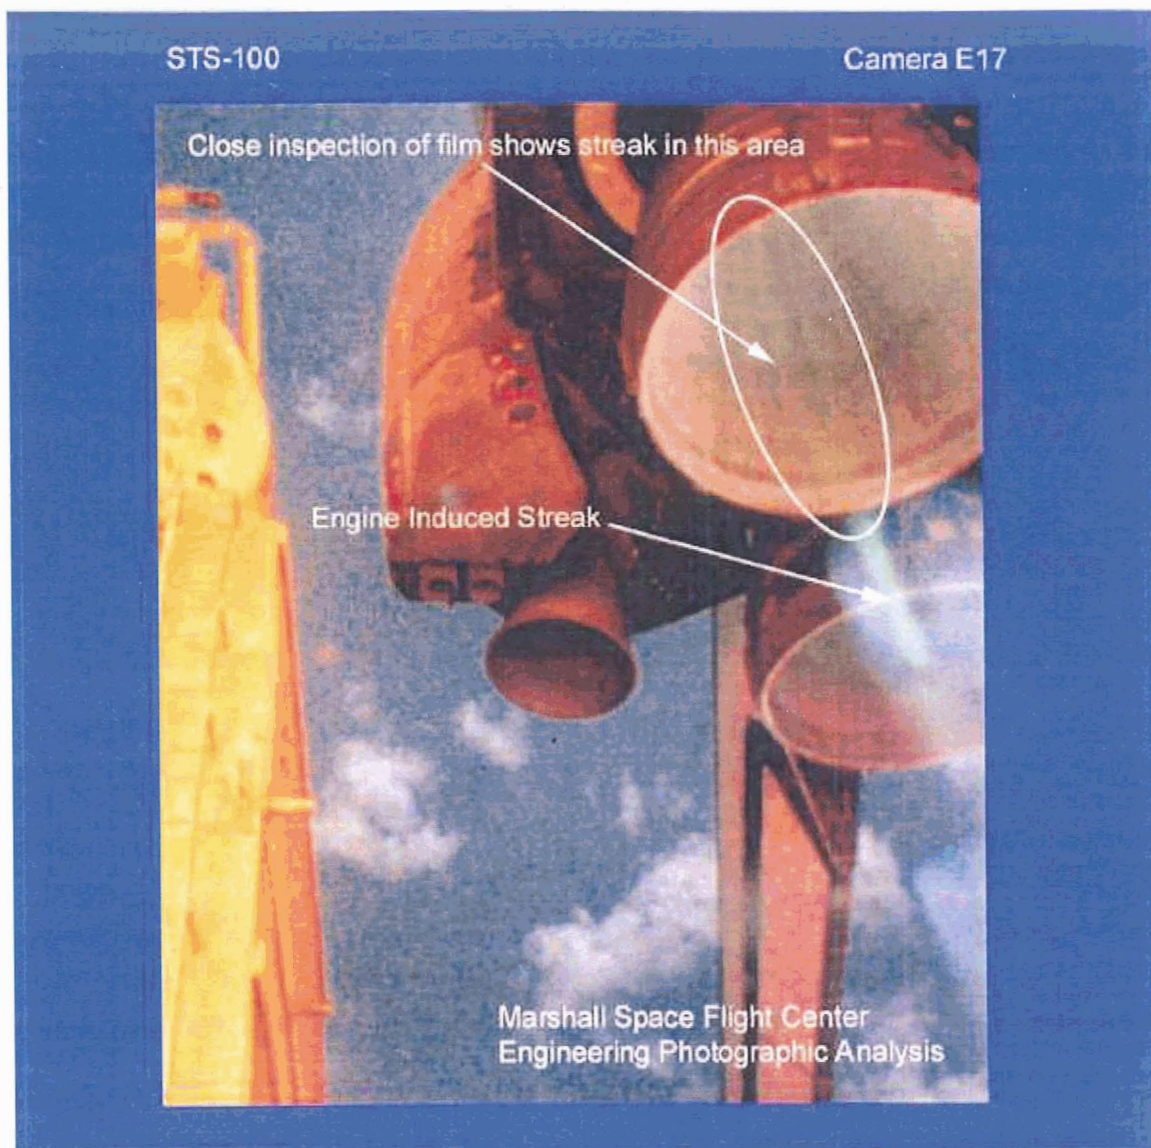
A green-colored engine streak in SSME#3 plume was noted on film from Camera E17 at 109:18:40:43.624 UTC. A faint greenish-yellow line may be observed extending from the upper tip of the green-colored streak to the edge of the nozzle.

Figure 10. Green-colored Engine Streak in SSME#3 Plume

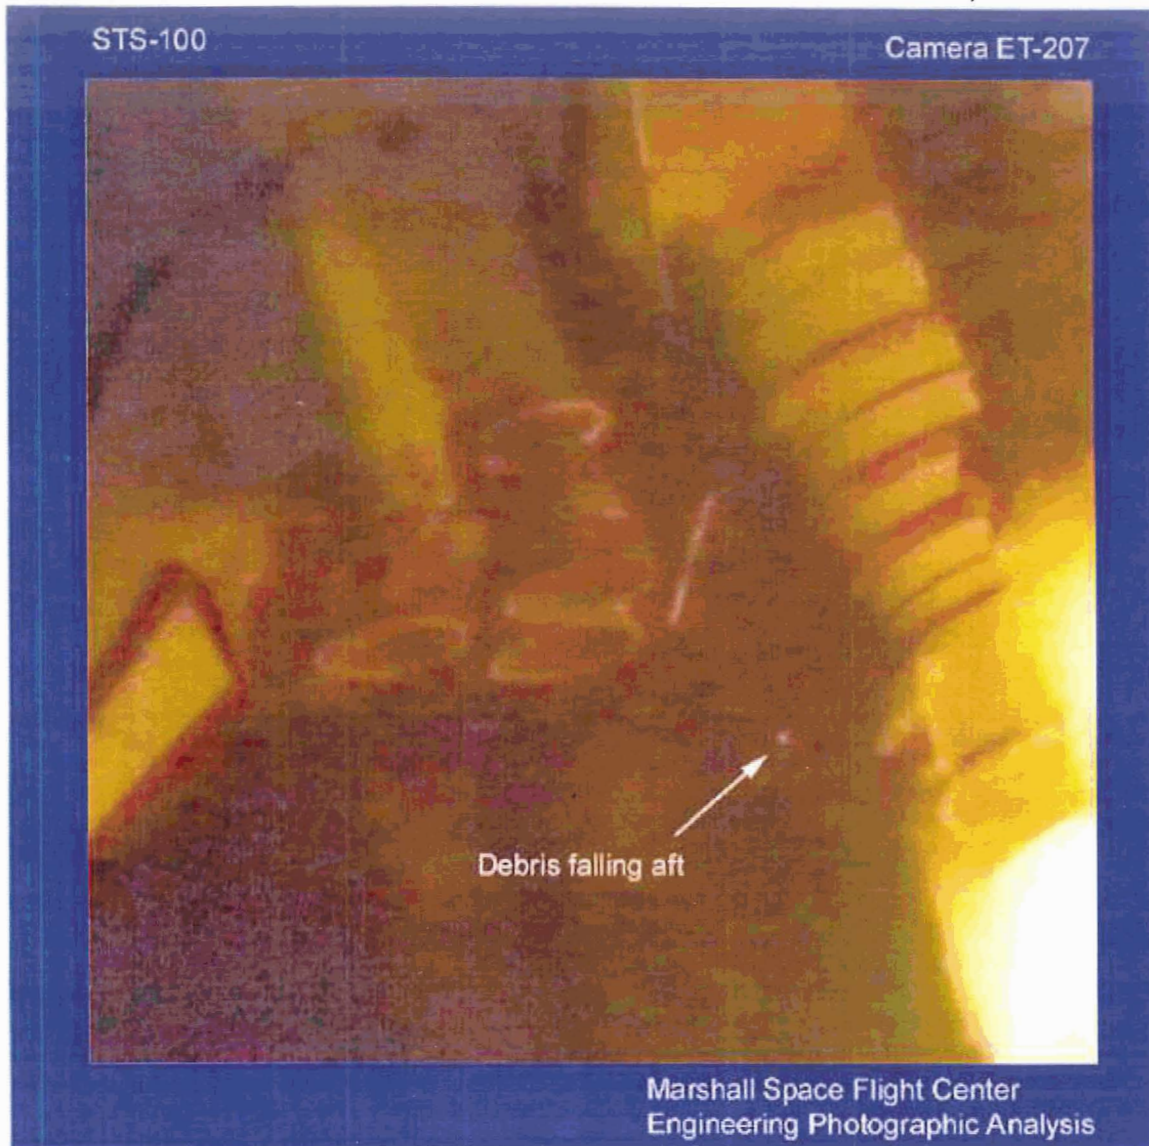
A notable debris object was observed falling aft of the Orbiter during ascent.

Figure 11. Debris Falling Aft of Orbiter

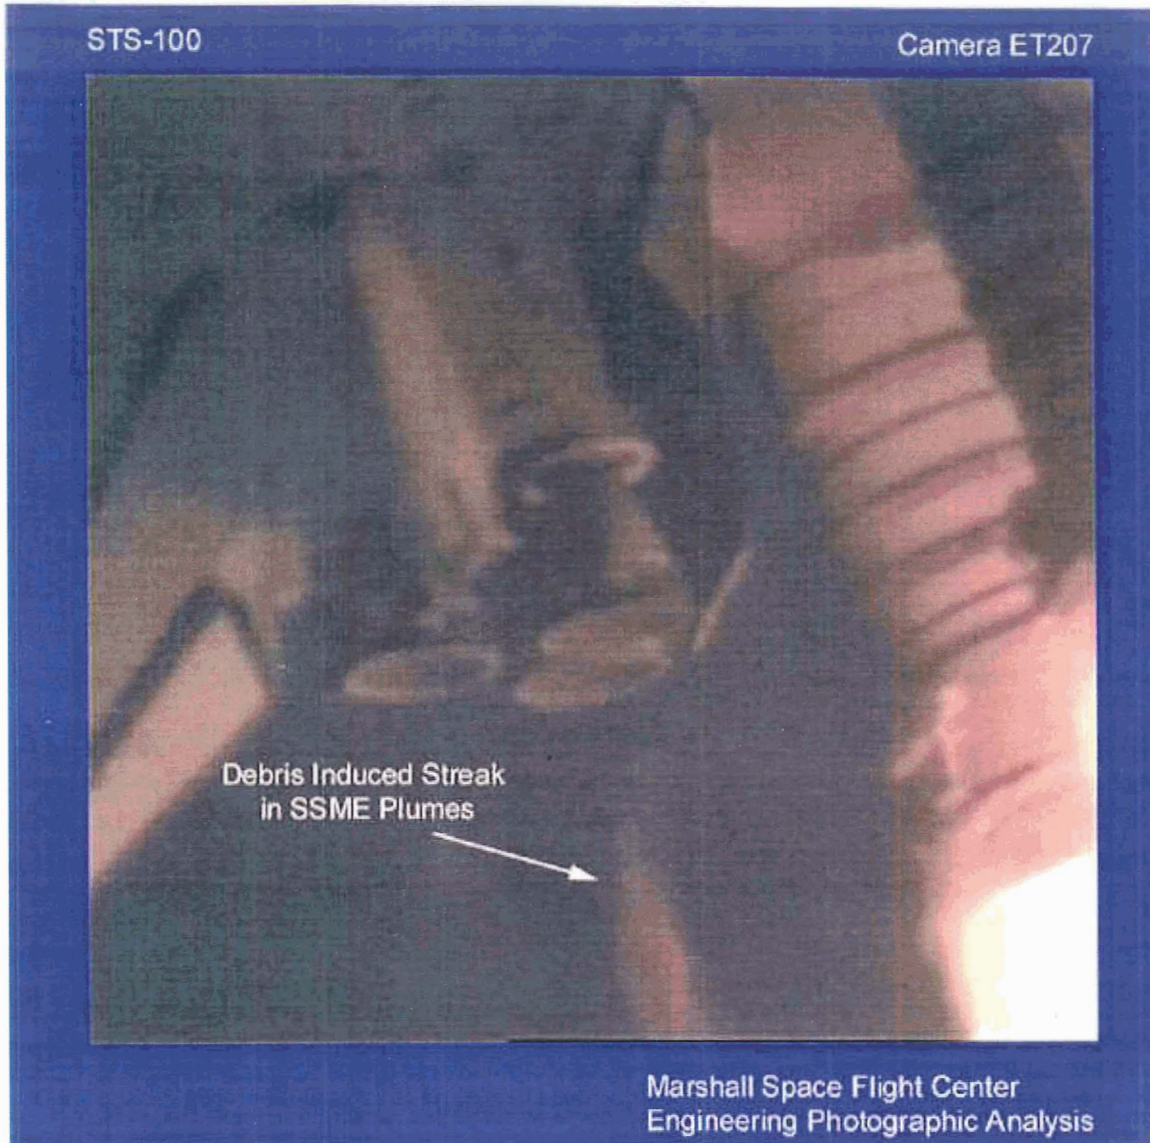
Several debris induced streaks, and possibly engine streaks, in the SSME plumes were noted during ascent. Figure 12 illustrates one such event.

Figure 12. Debris Induced Streak in SSME Plumes
